CONNECTICUT RIVER BASIN
FARMINGTON/NEW BRITAIN, CONNECTICUT

BATTERSON PARK POND DAM CT. 00262

PHASE I INSPECTION REPORT NATIONAL DAM INSPECTION PROGRAM

DECEMBER 1978

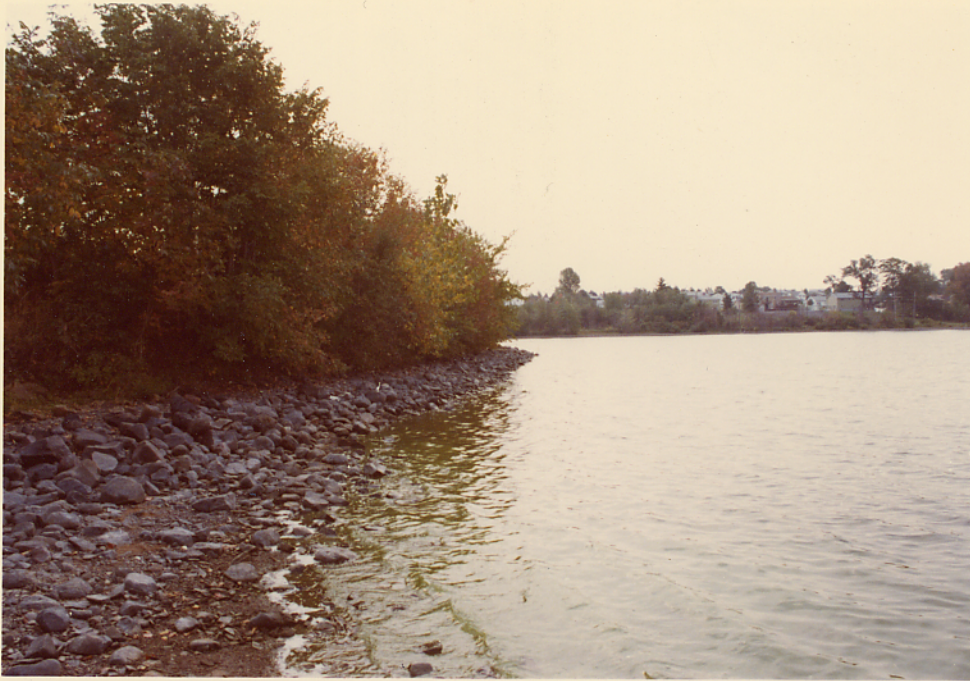
PHOTO 1
UPSTREAM FACE OF DAM

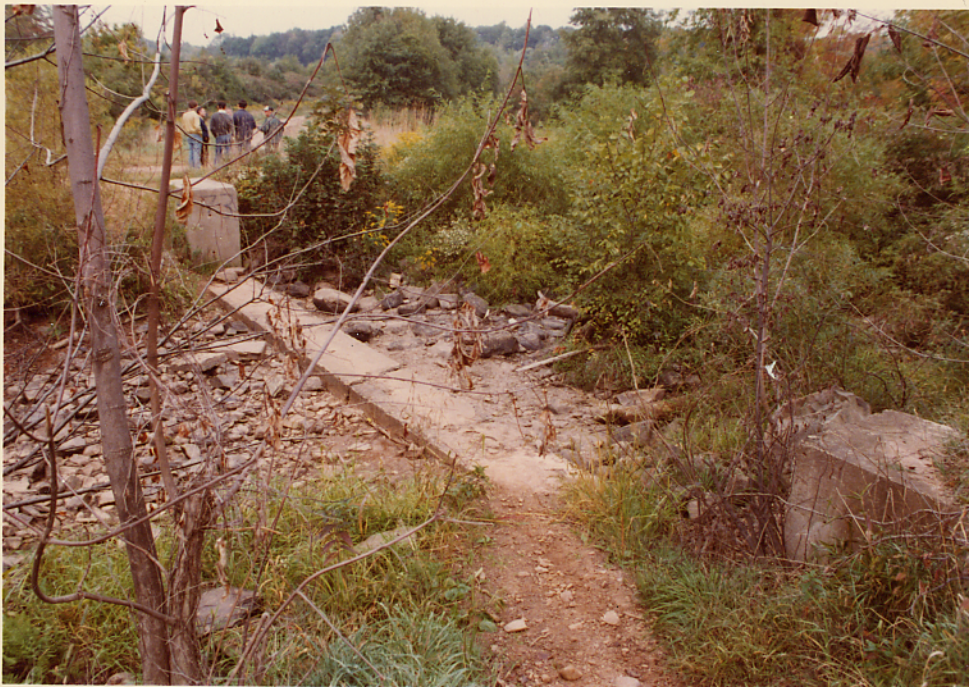
c. Appurtenant Structures - The appurtenant structures are the spillway (Appendix C, Photo 2) and the gate house which has been partially removed from the pond area. It was not clear exactly what happened to the gate house or the walkway which went to it. The spillway is overgrown and spalled with some cracks but there are no major signs of distress or movement (Appendix C, Photo 2). Since there are gate valves at the outlets of the blowoff, the removal of the gate house has caused the full head to be placed on the pipes. This, however, does appear to be within the design limits. These outlet gate valves are operable. The valves are exercised every year to lower the pond in the fall. The day before the inspection, maintenance personnel from the City of Hartford had opened the gate for the blowoff to start this drawdown process.

c. Visual Observations - The spillway at the time of the inspection was in poor condition with the spillway channel in need of cleaning (Appendix C, Photo 2).

PHOTO 2
CREST OF EMERGENCY SPILLWAY

- (2) Loose materials and brush should be cleaned from the spillway channel.
- (3) Eroded portions of the top upstream slope of the dam should be filled and reinforced.
- (4) Plans for around-the-clock surveillance should be undertaken for periods of unusually heavy rains and a formal warning system should be developed.
- (5) A program of biennial periodic technical inspection should be established.
- (6) Mini-bikes and recreational vehicles should be banned from riding on the dam.
- (7) A method to prevent vandalism to the valve boxes and to the outlet gate valves should be devised.

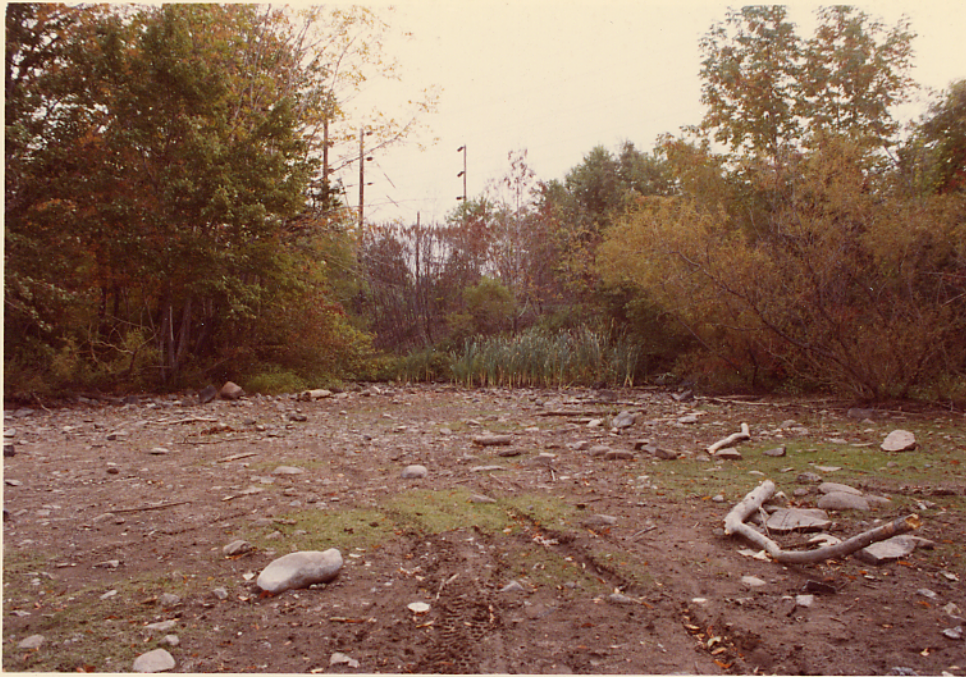
PHOTO 3
UPSTREAM SPILLWAY CHANNEL

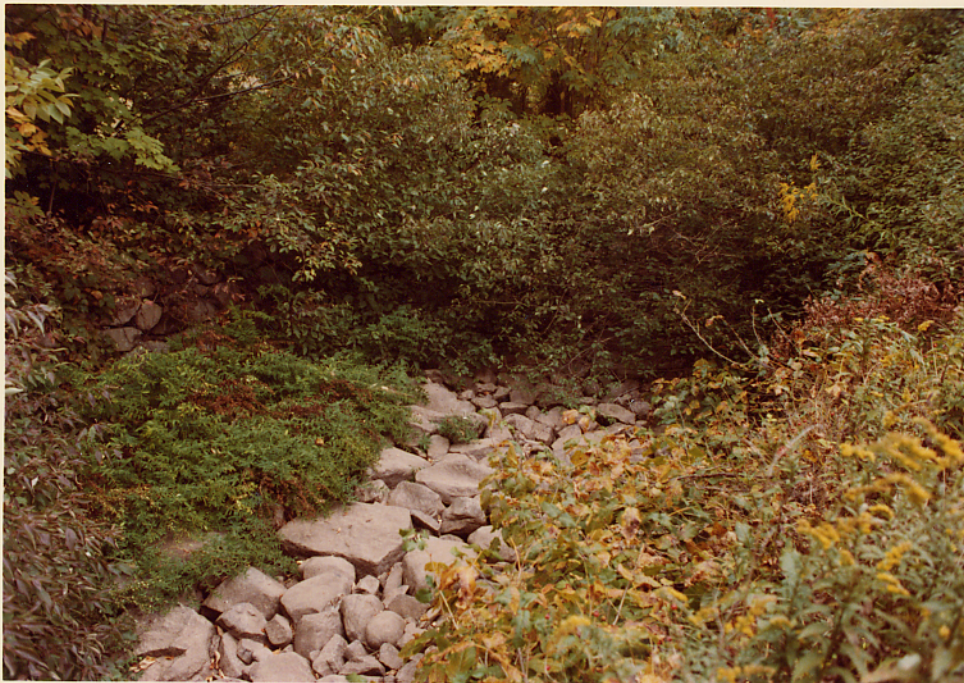
PHOTO 4
DOWNSTREAM SPILLWAY CHANNEL

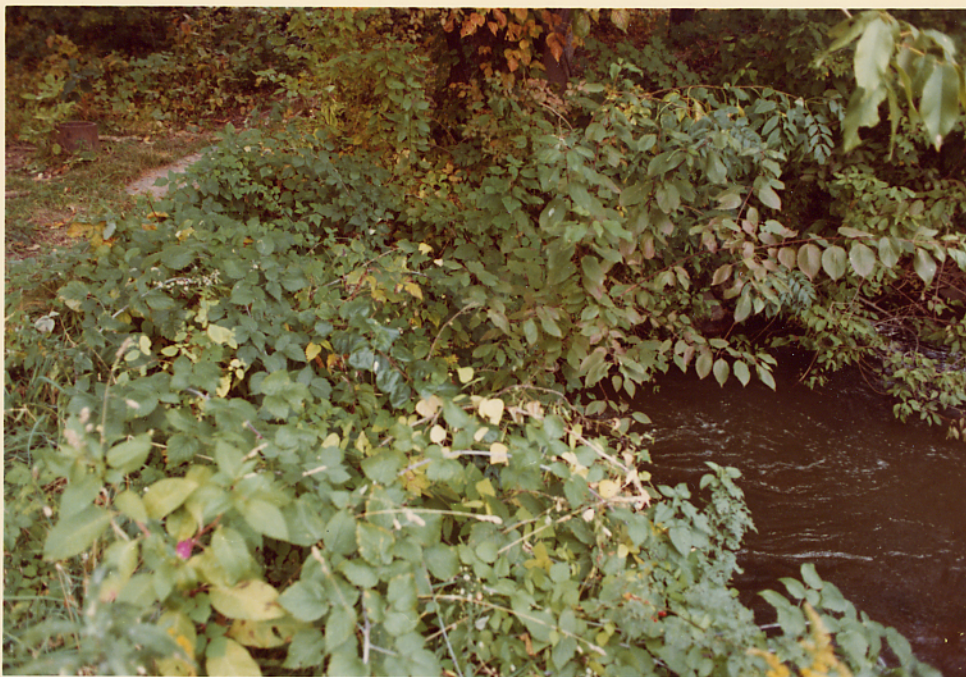
PHOTO 5
DOWNSTREAM BLOWOFF AT TOE OF DAM

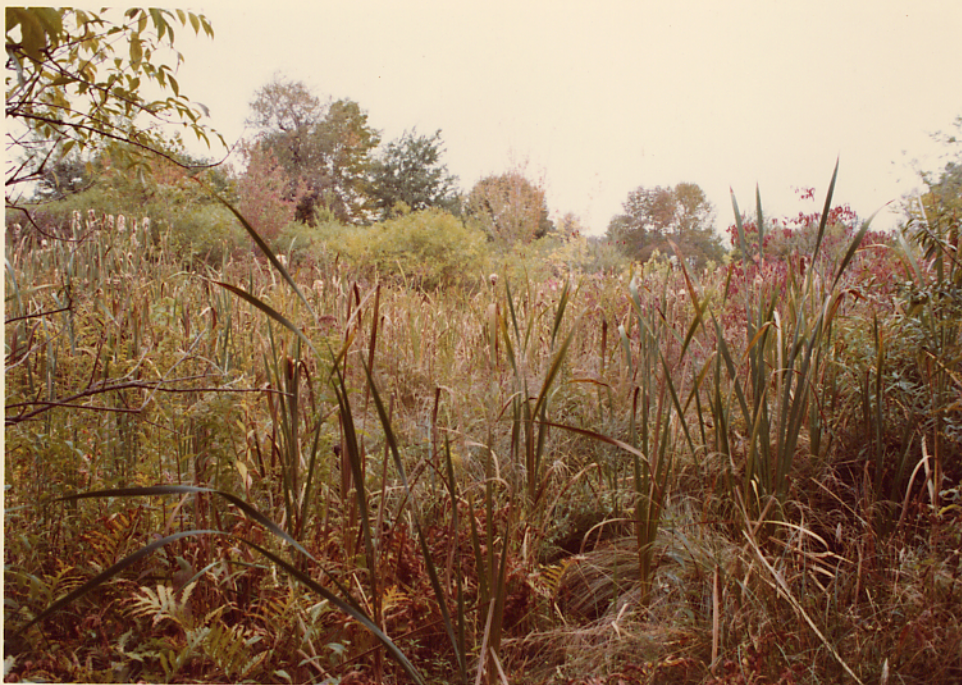
PHOTO 6
WET AREA AT TOE OF DAM

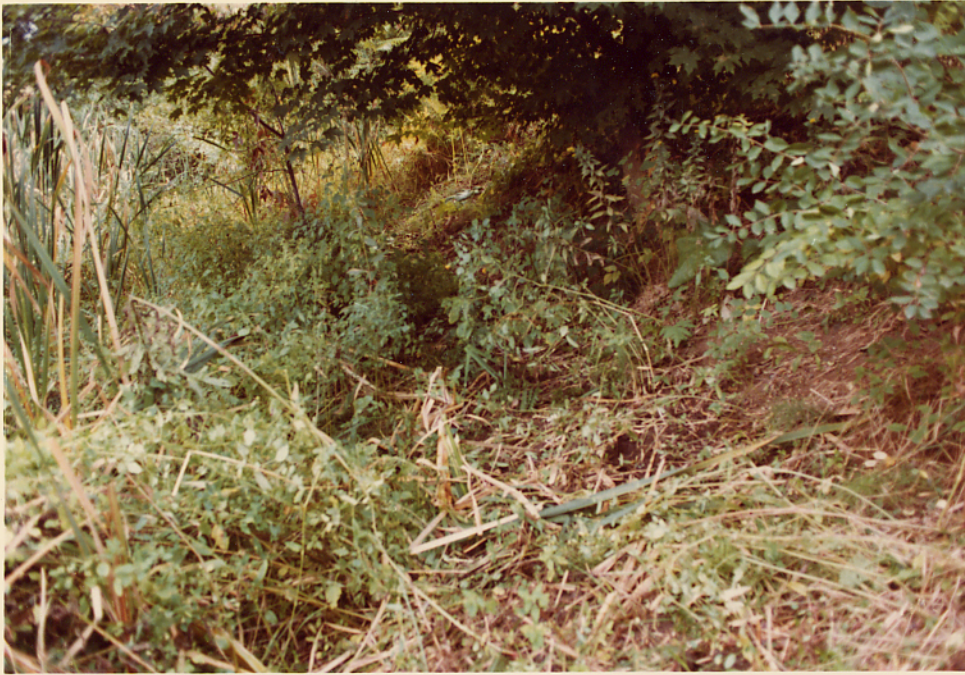
The lower part of the dam shows several signs of seepage with water being observed from as high as three (3) feet up from the toe of the slope (Appendix C, Photos 7 and 8). The total seepage discharge is approximately 10 to 15 gallons per minute. A marshy area is denoted on Plate 1 and shown in Appendix C, Photo 6. Some of the spots where seepage was measured had fairly substantial flows with minor deposits of redish color sediment and are shown in Appendix C, Photo 8.

PHOTO 7
SEEPAGE THROUGH BODY OF DAM

- a. Monitoring of the dam for seepage including any necessary analyses or other pertinent studies.
- b. Determination of the geometry of the dam, elevation of its base, properties of its components and its foundation rock should be made. This would permit an objective assessment of the structural stability of the dam;
- c. Further detailed studies of the spillway capacity and an investigation into possible methods to increase the total project discharge capacity if this is found to be necessary.

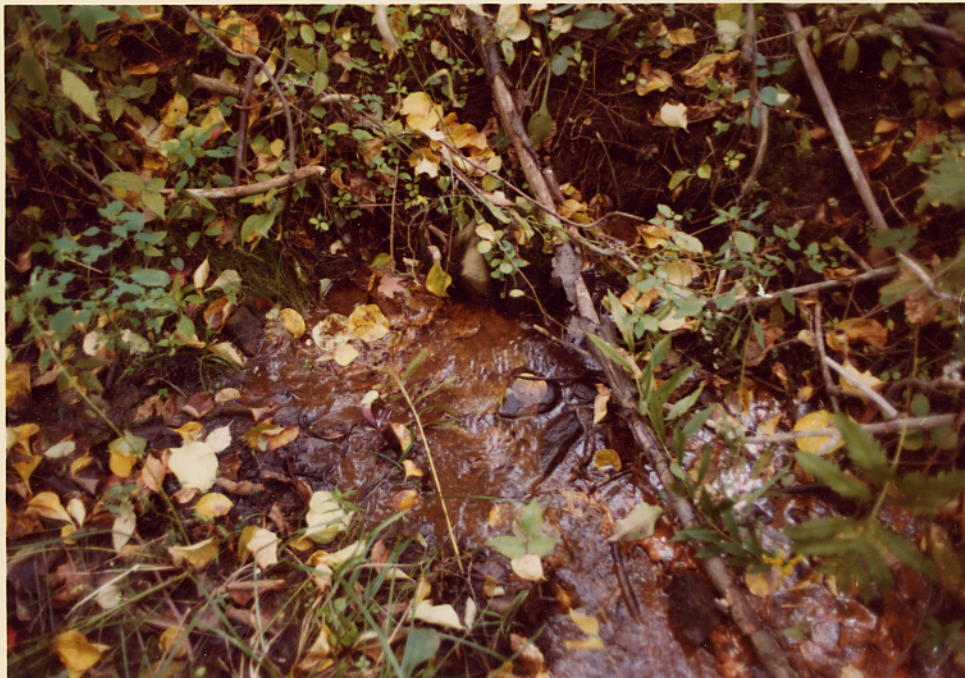
PHOTO 8
SEEPAGE AREA NEAR TOE OF DAM
